**DEPARTMENT OF TRANSPORTATION****DIVISION OF ENGINEERING SERVICES**

Contract #: 04-0120F4Cty: SF/ALA Rte: 80 PM: 13.2/13.9File #: 69.28**WELDING INSPECTION REPORT****Resident Engineer:** Pursell, Gary**Address:** 333 Burma Road**City:** Oakland, CA 94607**Report No:** WIR-001150**Date Inspected:** 04-Jan-2008**Project Name:** SAS Superstructure**OSM Arrival Time:** 1400**Prime Contractor:** American Bridge/Fluor Enterprises, a JV**OSM Departure Time:** 2330**Contractor:** Zhenhua Port Machinery Company, Ltd (ZPMC), Changxing Island **Location:** Shanghai, China**CWI Name:****CWI Present:****Yes No****Inspected CWI report:** **Yes No N/A****Rod Oven in Use:****Yes No N/A****Electrode to specification:** **Yes No N/A****Weld Procedures Followed:****Yes No N/A****Qualified Welders:** **Yes No N/A****Verified Joint Fit-up:****Yes No N/A****Approved Drawings:** **Yes No N/A****Approved WPS:****Yes No N/A****Delayed / Cancelled:****Yes No N/A****Bridge No:** 34-0006**Component:** Tower Mock Ups, OBG components**Summary of Items Observed:**

## WELDING INSPECTION REPORT

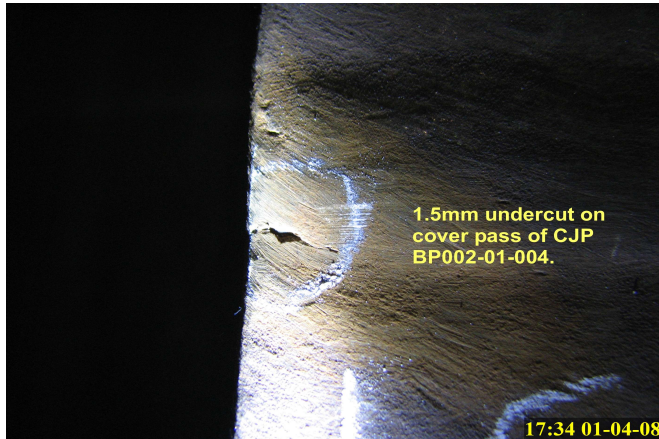
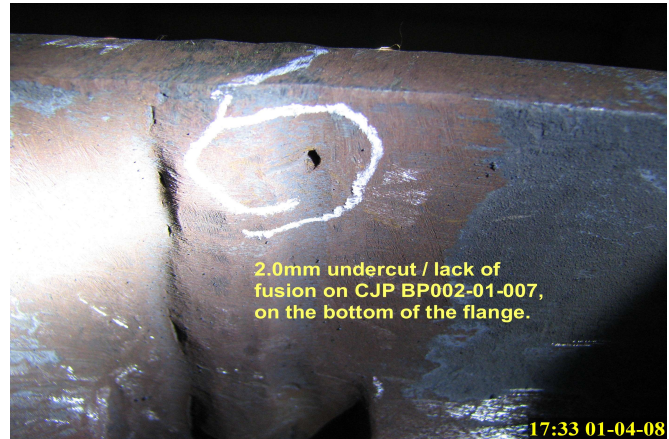
weld faces to conduct a thorough visual examination of the weld. The QA inspectors identified a portion of the bottom of the complete joint penetration (CJP) weld that appeared to have 3.0mm deep lack of fusion. The QA inspector Joe Lanz showed this observation to the Quality Control Liaison (QCL) Lay Tau. The QCL was informed that the weld was visually non-conforming to AWS D1.5 2002 requirements. After these observations were made, the QA inspector conducted random visual examinations of similar completed welds that were accessible in Bay 3. The QA inspector identified several welds that have been visually inspected and accepted by CWI Xu Xian Ping. The QA inspector observed BP002-01-007 appears to have 2.0mm undercut and BP002-01-004 appears to have 1.5mm undercut. Both of these welds are CJP butt splices on T-stiffener flanges. The QA inspector informed the QCL Lay Tau of these observed welds. See the attached photos.

The QA inspector Scott Croff was asked by the QA inspector Joe Lanz for assistance in identifying an indication that was being observed with UT. There were conversations regarding the location of the indication and the possible causes. The QA inspectors decided to clean the welds and examine all surfaces of the CJP. The QA inspectors noted that near the weld access hole in the T-stiffener web there appeared to be lack of fusion between the weld and the base metal. This discontinuity was measured a 3.0mm deep and the QA inspectors believe that it was causing the UT indication. The QA inspector Joe Lanz then informed the QCL Lay Tau that the weld appeared to be visually non-conforming. The QCL Lay Tau then spoke with ZPMC technician Li Li Ming. They examined the weld and informed the QA inspectors that the weld needed to be repaired. Also as noted above, the QA inspector Scott Croff informed the QCL Lay Tau of the other welds that appeared to be visually non-conforming.
